ContiTech

New idler in the kits CT1014K2/ K5/ K3 and CT1078K1 for diverse Opel/ GM 1.7 DI/ DTI/ CDTI

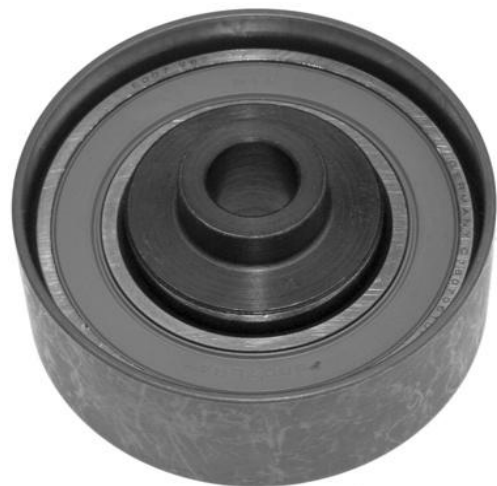
According to the manufacturer catalogue, the old idler pulley (Fig. 1) is no longer used. The new type now being installed (Fig. 2) has a ball bearing with no flange.

Fig.2
new idler pulley V55368

Despite its varying design, the new type can be installed directly instead of the old steel idler.
