Blue Print ADC41473

Mitsubishi Airtrek 2.0i 2001>2006, Carisma 1.6i 1.8i 1995>2004, Colt 1.6i 1996>2004, FTO 1.8i 1995>2000, Galant 2.0i 1997>2004, Shogun Pinin 1.8i 2001>2006, Space Runner 2.0i 1999>2003, Space Star 1.3i 1.6i 1.8i 2000>2005, Space Wagon 2.0i 2.4i 1998>2004

IGNITION COIL FAILURE

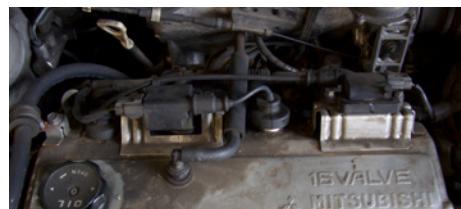
Typical examples below are from the two original coil failures.

Example A was tracking from the coil body to the laminated core.

Example B shows where the spark has tracked along the spark plug ceramic (see burn marks).

Blue Print strongly recommend that the spark plugs and HT leads are replaced in addition to the coil assembly, or that they are carefully checked. We also recommend that a logical diagnosis procedure is followed (prior to replacing the ignition coil) to prevent it being replaced unnecessarily.
