# Blue Print ADM51498

To fit:

Mazda CX3 2015>, CX5 I 2011 > 2016, CX5 II 2016>, Mazda2 III 2014 > 2022, Mazda3 III 2013 > 2019, Mazda6 III 2012>, MX30 2020>

## Ignition Coil

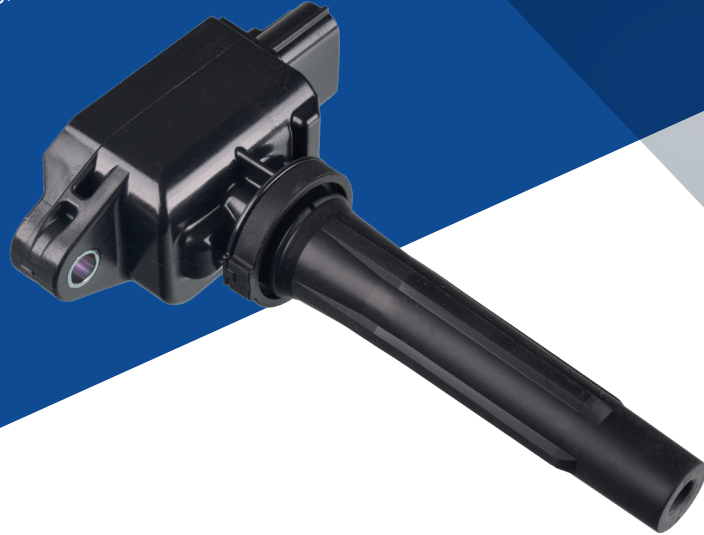
Vehicle symptoms include a lack of engine power and an inconsistent idle, combined with the engine malfunction indicator lamp being illuminated on the instrument cluster. Engine Control Unit (ECU) diagnostics will reveal the following possible fault codes:

Over time the insulation found between the primary and secondary coil windings is degraded by heat and vibration. This deterioration causes fractures to form in the secondary coil windings, leading it to overheat and fail, resulting in a misfire.

Note: There is a known issue which affected some pre-2017 vehicles fitted with ignition coils manufactured by Yumebishi.

First, use suitable diagnostic equipment to identify which ignition coil is causing the misfire. Alternatively, this can be diagnosed manually by removing each spark plug and systematically testing the coils to establish which is not firing correctly.

Each ignition coil is required to provide a high voltage to bridge the electrode gap. If the ignition coil insulation is degraded, additional load will be placed upon the system. Therefore, when the faulty ignition coil has been identified, it is wise to check the condition of the plugs themselves as they too can deteriorate with age, further increasing the load on the system.

Disconnect the battery and replace the failed ignition coil (or coils) with Blue Print Ignition Coil ADM51498 and spark plugs as necessary. Finally, reconnect the battery and clear any fault codes using a suitable diagnostic tool.
