**New tensioning pulley is different from the old one and can't be tensioned.
Timing belt kit CT1168K1/ WP1/ WP2 for Audi, Seat, Skoda and VW.
Various models of 1.4 – 2.0 TDI common rail, EA288**

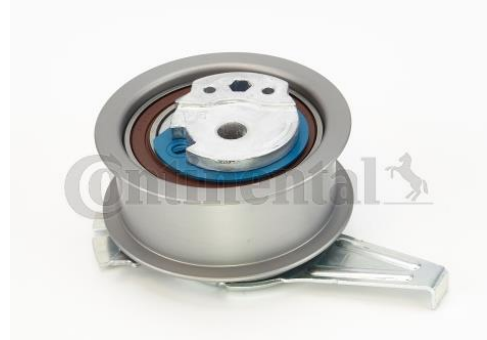
Fig. 1

The supplied tensioning pulley V56390 looks different from the one installed in the vehicle. It obviously cannot be tensioned in the way described in the fitting instructions.
