93172

1.9 TDi 66-77 KW

ISSUE INTAKE AIR SYSTEM

COMPRESSOR WHEEL DAMAGES BY FOREIGN OBJECTS

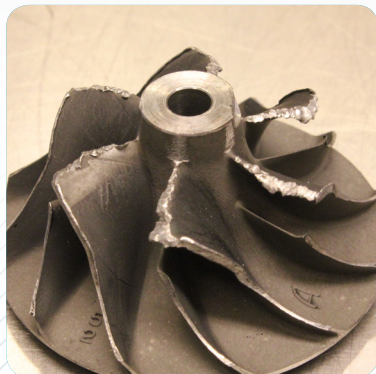
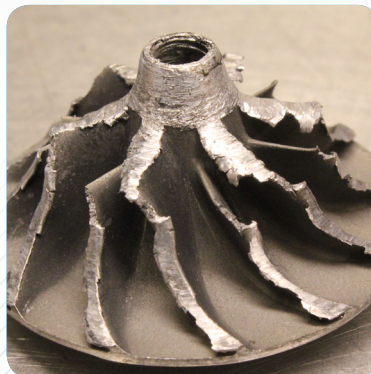
One of the most common causes of turbo failure are foreign objects damaging the compressor wheel. The objects are typically drawn in via the air intake system. When they hit the compressor wheel, moving at its high RPM, they can cause serious damages to its blades. The blades break off and the splinters cause further damage to the entire wheel assembly.

Compressor wheel damage caused by foreign objects

- Thoroughly clean/vacuum air filter box
- Install new air filter
- Check condition and if necessary replace all hoses and pipes between turbo and air filter box, including MAF sensor
- Check if any foreign objects/parts from the damaged turbo are located in the air intake system and remove if so
- Check to ensure the crankcase ventilation system operates properly, and clean or replace if necessary
