Fiat 500

Clutch Replacement

The example featured in this article is a 2008 model equipped with the proven 1.2 litre, four-cylinder FIRE engine, which was suffering with a clutch pedal that was 'stiff' to operate. This required the transmission to be removed to investigate and diagnose the cause.

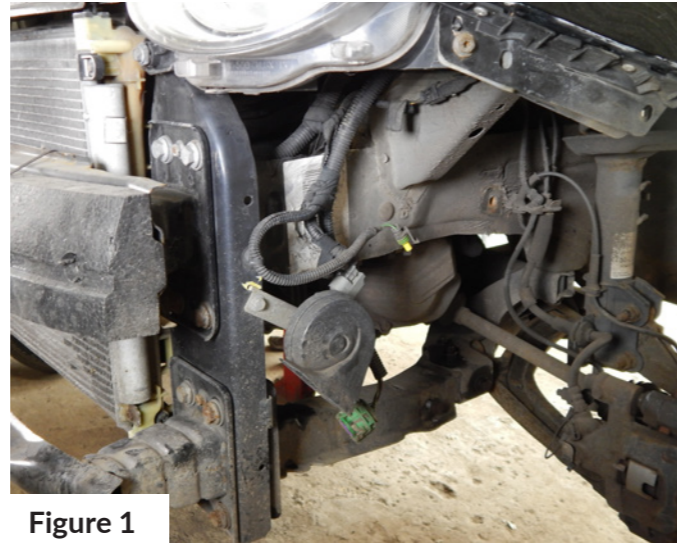
Figure 1

The front cross-member is then revealed - this requires removal, as does the left-hand section of the sub-frame. There will now be enough room to remove the transmission from the engine. (Fig.1)

With the car on the ramp, the clutch replacement process can begin. First, remove the front bumper to gain access to the sub-frame. Both front wheels can then be removed, followed by the wheel-arch liners and the strengthening brackets bolted to the body and sub-frame. This allows access to unclip the wiring harness from the lamps mounted in the bumper and fixings. This can be taken off in one piece once all screws are removed.

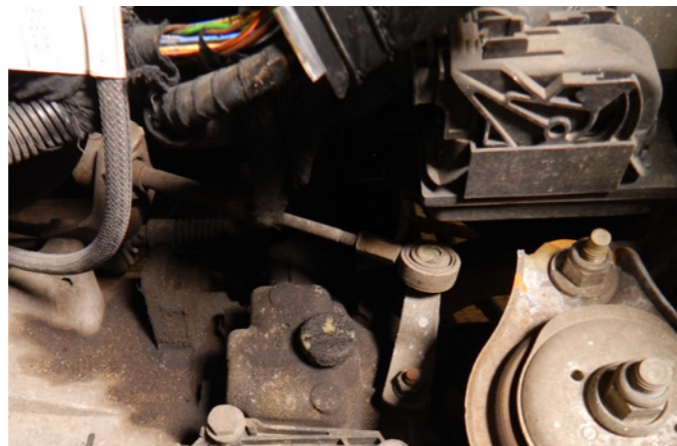
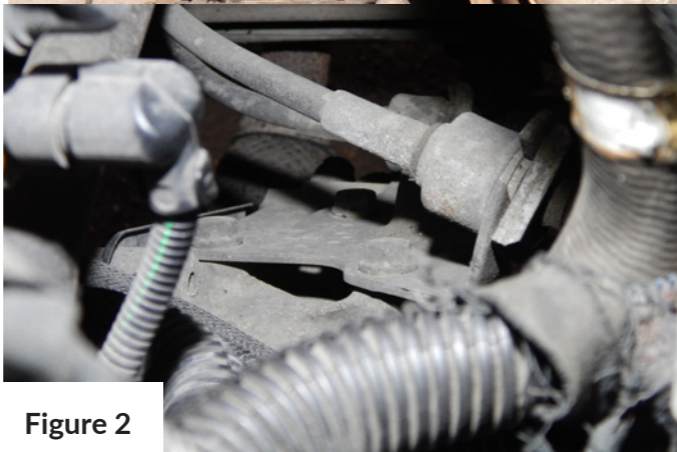
Figure 2

the battery and battery tray to reveal the top of the transmission. Now, the clutch-slave cylinder can be unbolted from the transmission, and the gear-selector rods unclipped from the linkage. Additionally, unbolt the bracket retaining them to the transmission. (Fig.2) At the same time, you will also need to remove the bell-housing bolts located at the top of the transmission, including one starter motor bolt. Raise the vehicle to a working height, remove both driveshaft hub nuts and release the lower suspension-arm ball joints from their hubs. This is in readiness for the driveshaft removal.

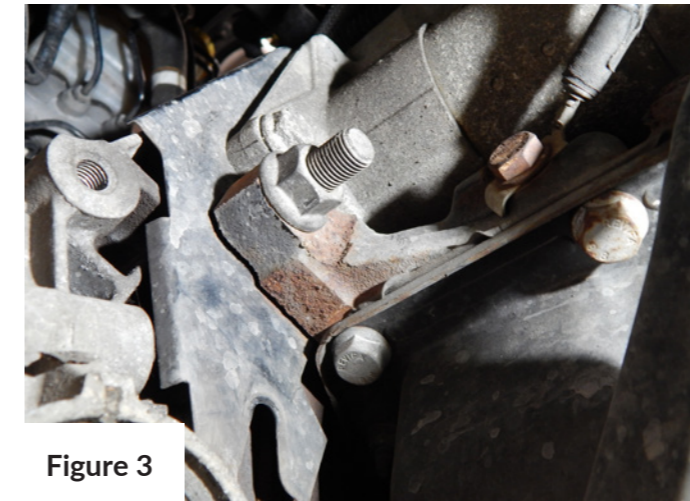
Figure 3

It is now time to unbolt and remove the reaction rod bolted to the back of the engine block (below the starter motor and the flywheel-protection plate). After this, remove the other starter motor fixings but leave the starter motor in place - it does not need to be taken out completely for the removal of the transmission. (Fig.3)

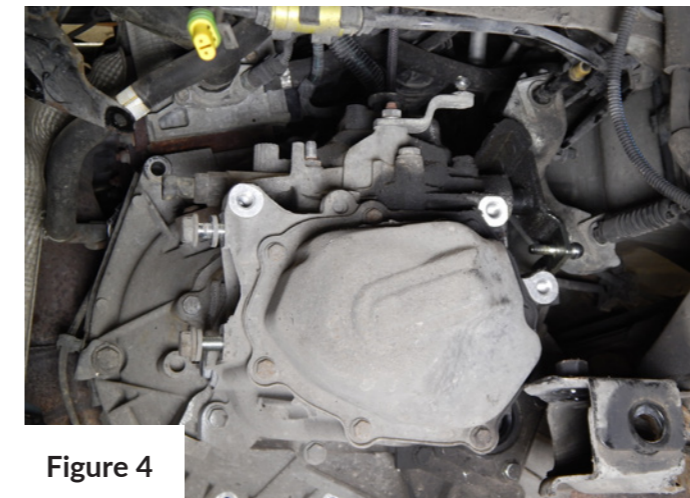
Figure 4

With only the lower bell-housing bolts in place and the transmission mountings left to remove, the engine can be supported ready for removal. Unbolt the lower bell-housing bolts, including the mounting brackets - giving enough room for the transmission to be separated from the engine and lowered from the vehicle for inspection. (Fig.4)

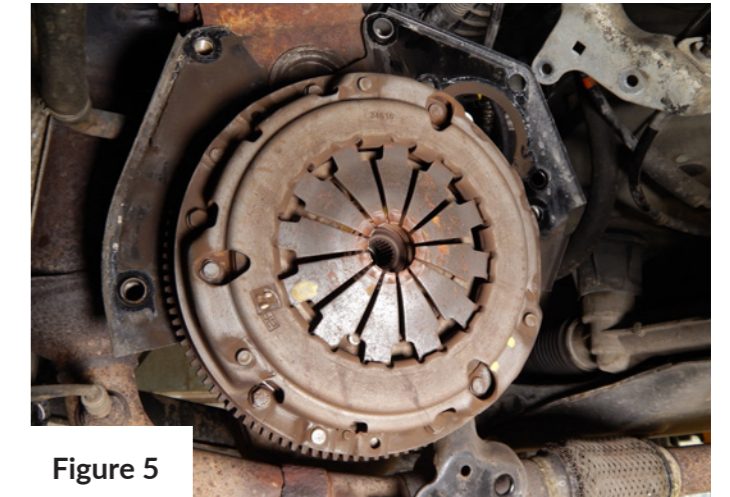
Figure 5

Remove the clutch-pressure plate and friction disc from the flywheel in order to inspect them for any unusual wear issues. During our inspection of the 2008 model featured in this article, the flywheel was in good condition and only required cleaning. However, the friction disc material was close to being worn out and there was significant wear on the pressure-plate diaphragm springs; this being the cause of the 'stiff' operation of the clutch pedal. (Fig.5)

Turning your attention to the release mechanism, it is recommended to thoroughly clean the transmission bell-housing to free it from all grease, dirt and old friction fibres from the previous clutch. Remove the release bearing from the clutch fork and inspect the guide sleeve for wear. In the case of the model featured in this article, the driveshaft seals were replaced to reduce the risk of any leaks due to the ageing of the old seals.

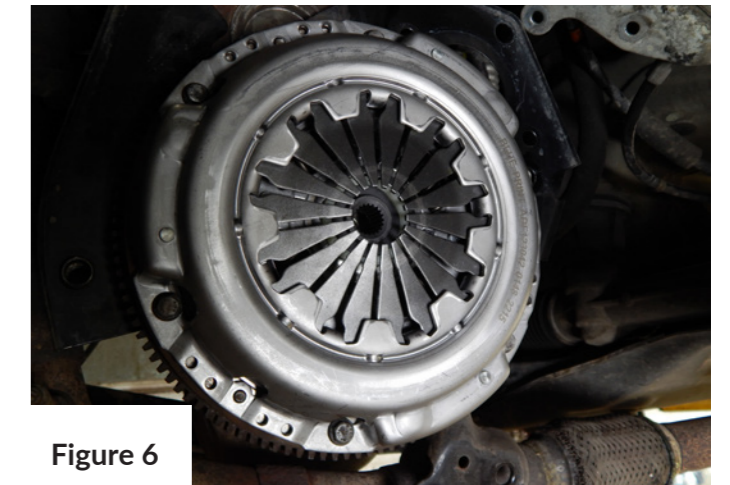
Figure 6

With all parts inspected, it is time to replace the clutch. Our chosen clutch kit - ADF123042 - was opened and readied for use. (Fig.6)

To begin, align the new friction disc and pressure plate to the flywheel, with all bolts tightened to the recommended torque. Then, clip the new release bearing onto the release fork and test it for operation. If it is working correctly, the transmission is ready for reinstallation to the engine.
