Blue Print – MINI Clutch Replacement

The featured vehicle, a MINI One Countryman, was fitted with the popular 1.6 petrol PSA group engine, which can be found in many Peugeot, Citroën, Opel/Vauxhall and BMW models. This example was in the workshop for an annual inspection. It was reported to the owner that the clutch was starting to slip. (Fig 1)

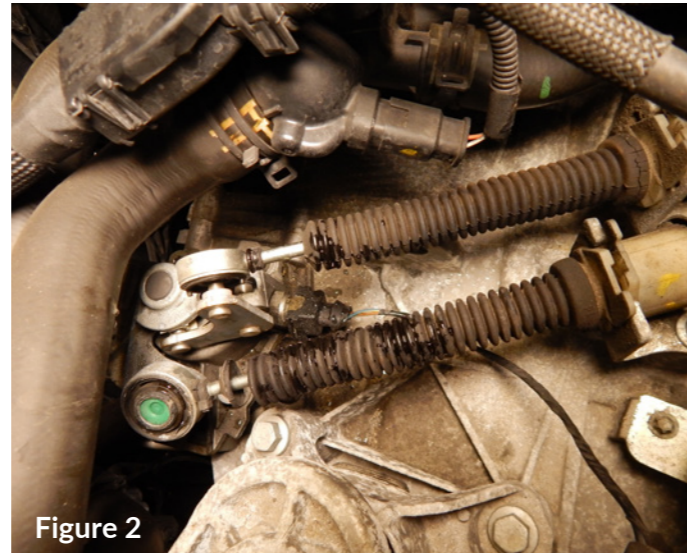
Figure 2

After getting the vehicle into the workshop and onto the ramp, the bonnet was opened, and the battery was disconnected. This is located in front of the bulkhead under an access panel below the windscreen. Working from the top, the coolant expansion tank was removed and was put to the side. The fuse box cover and engine ECU retainer were then removed. The air intake hose and vacuum pump plastic pipe were removed as well. With these components taken off, the gear selector cables were revealed. The cable bracket could then be unbolted, and the cables could be unclipped from the selectors. One aspect that was not and should not be forgotten is to disconnect the reverse lamp switch connector. It should also be secured so it does not get in the way. (Fig. 2)

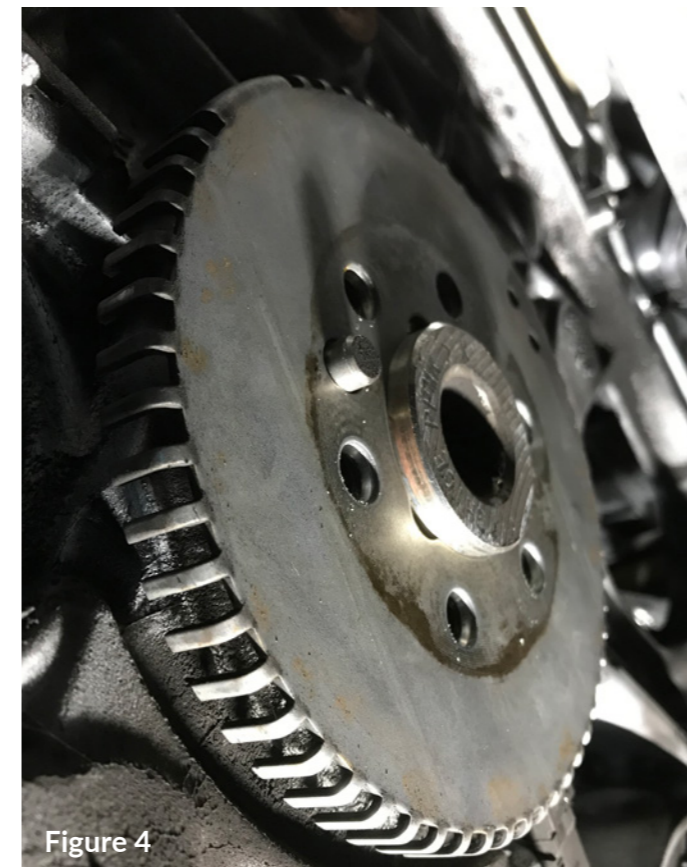
Figure 4

With the transmission supported, the transmission mounting retaining bolts were removed. Then, the rest of the bellhousing bolts were also removed. The transmission was separated from the engine, leaving enough room to access the clutch. The six pressure plate retaining bolts were undone and the clutch was removed and inspected. The clutch had endured a hard life, as there was evidence of hot spots and cracks in the mating surfaces of both the pressure plate and flywheel. Because of this, it was decided to replace both the three-piece clutch kit and the flywheel. The flywheel was taken off, leaving the reluctor ring in place (Fig. 4). This is only retained by the flywheel.

The release bearing was removed, and the sliding surface of the guide sleeve was inspected for wear and was lightly greased before fitting the new release bearing. The new flywheel was fitted with new bolts and tightened to the manufacturer's torque settings. This was followed by the installation of the new friction disc and pressure plate.
