Modified Multi V-Belts

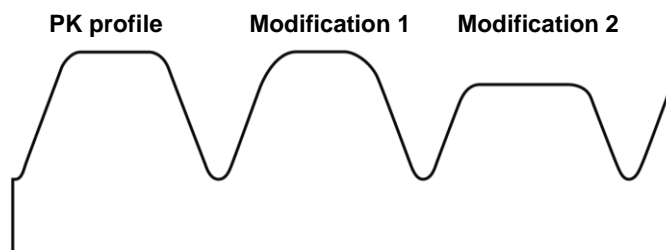
Multi V-belts that have been supplied differ optically and haptically from the conventionally used multi V-belts. The contact face has a different texture.

Greatly enlarged view of the different profile sections

These are modifications that either have been adopted from the original equipment or have arisen for reasons related to production operations. The aim is to achieve an optimal noise level and/or further improve the service life.

The modified belts can be used without reserve for the automotive applications specified in the catalog. Despite the optical differences, the new finish has no adverse impact on performance.

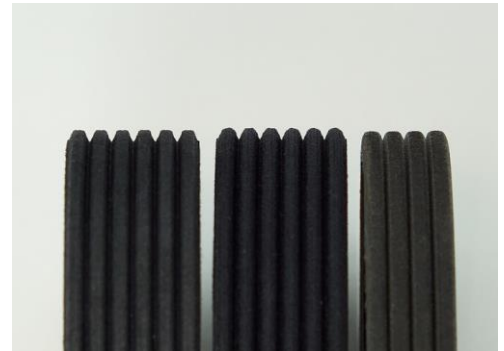
The modified profile section types – difficult to detect with the naked eye
