Volkswagen Caddy Clutch Replacement

A SMART Business Decision

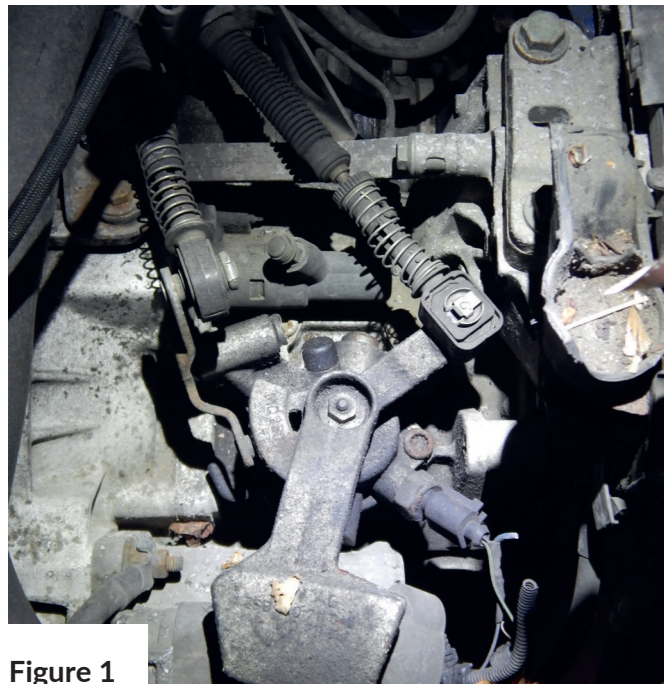
Figure 1

Once the vehicle was brought into the workshop, the bonnet was opened and the battery, battery tray, and air cleaner assembly were removed to allow access to the top of the gearbox. This revealed the gear selector, clutch slave cylinder, starter motor, and gearbox mounting. (Fig 1)

The gear selector cables were unclipped from the selector levers and the three retaining bolts removed from the cable bracket, with the cables put to one side.

The clutch slave cylinder was then unbolted and secured, followed by the reverse lamp switch, wiring harness, and starter motor, leaving only the gearbox retaining bolts in place.

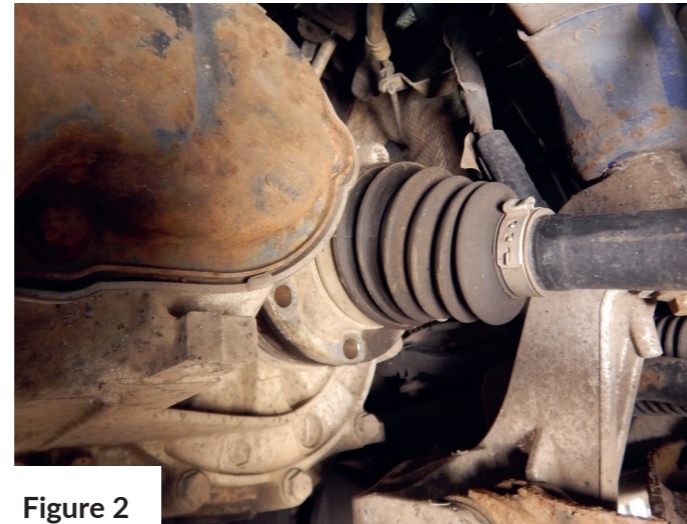
Figure 2

The vehicle was then raised to a working height and the front wheels were removed, followed by the left-front driveshaft retaining bolt, both lower suspension arm swivel joint retaining bolts (Fig 2), and finally, the left-hand wheel arch liner.

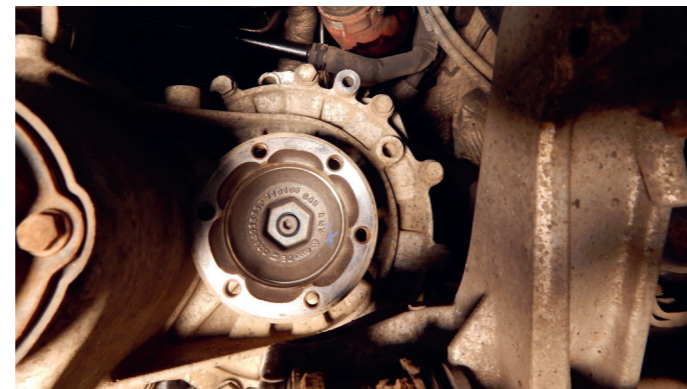
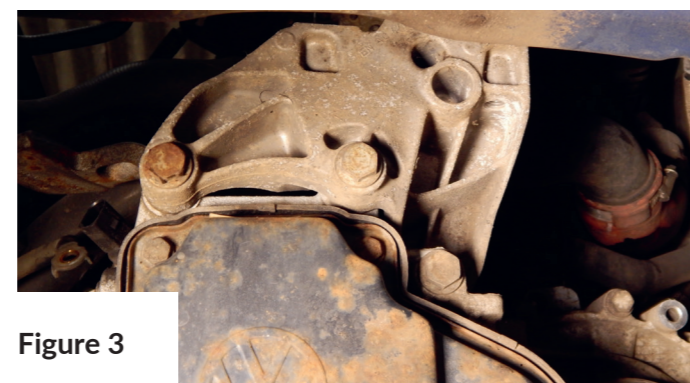
Figure 3

The inner driveshaft joint retaining bolts were undone which allowed the driveshafts to be pulled free from the drive flanges. The right-hand driveshaft was then secured to one side, and the left-hand driveshaft was removed completely to give clearance for the removal of the gearbox. (Fig 3)
