# Škoda Roomster Clutch Replacement

The model featured in this article is the later facelifted version, fitted with the popular 1.2 TSi engine and a 5-speed manual gearbox. The vehicle was reported to have an issue with the smoothness of its clutch pedal operation. This required the gearbox to be removed and the clutch inspected in order to fully diagnose the fault and rectify it.

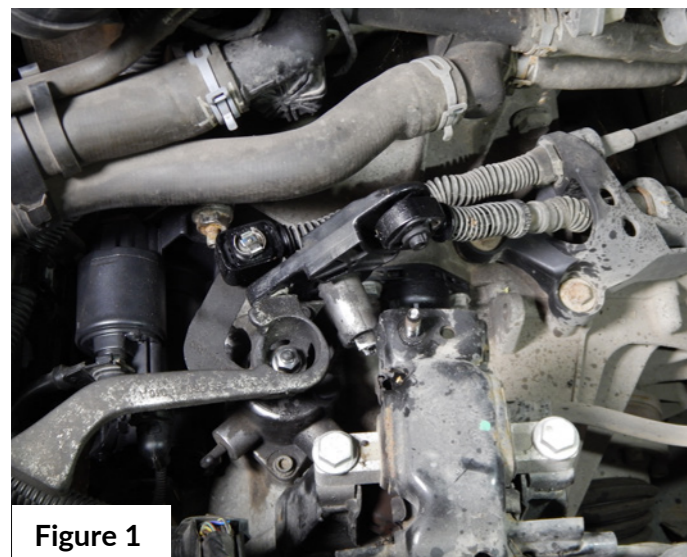
Figure 1

Once the vehicle was brought into the workshop, the bonnet was opened and the battery, battery tray and air cleaner assembly were removed to provide access to the top of the gearbox. This revealed the gear selector, clutch slave cylinder, starter motor and gearbox mounting. (Fig 1)

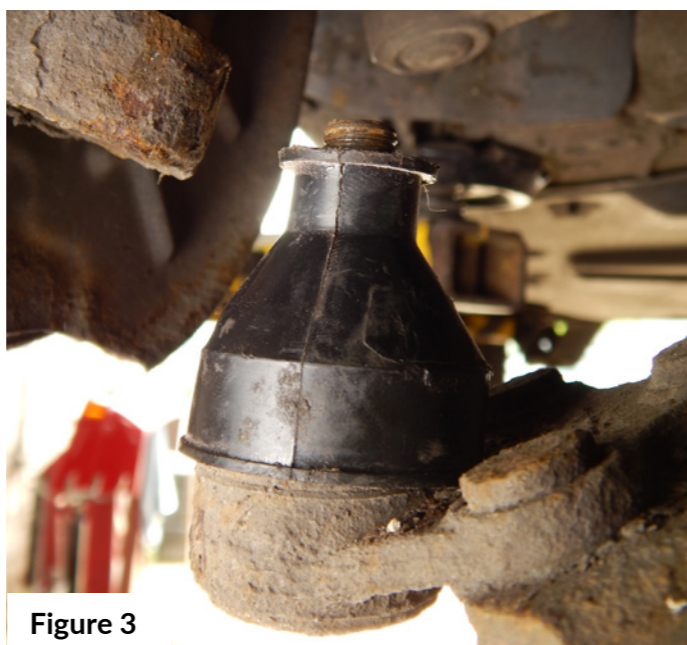
Figure 3

The front wheels were removed. This was followed by the removal of both lower suspension arm swivel joint retaining bolts. The joints were freed from the hub assemblies and covered with a plastic cap to protect the rubber boot and thread from any potential damage. (Fig 3) This was followed by the left-hand wheel arch liner.

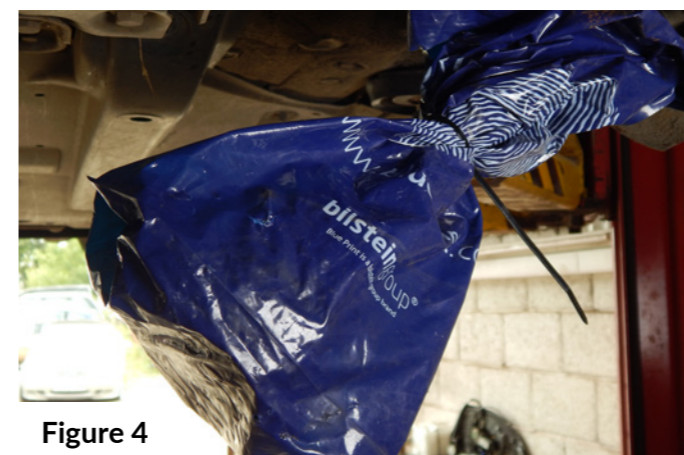
Figure 4

The inner driveshaft joint retaining bolts were unbolted. The driveshafts could then be pulled free from the drive flanges to provide ample clearance for the removal of the gearbox. The exposed driveshaft joints were wrapped in a plastic bag to stop any grit from entering the joint until they were ready to be refitted. (Fig 4)
