Control of Crankcase Emissions

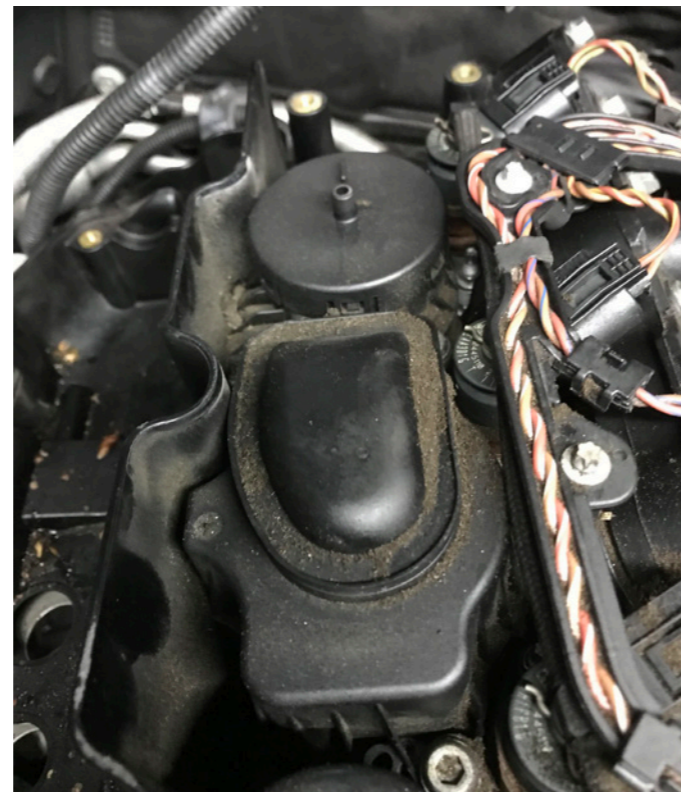
Example: Breather Valve for crankcase.

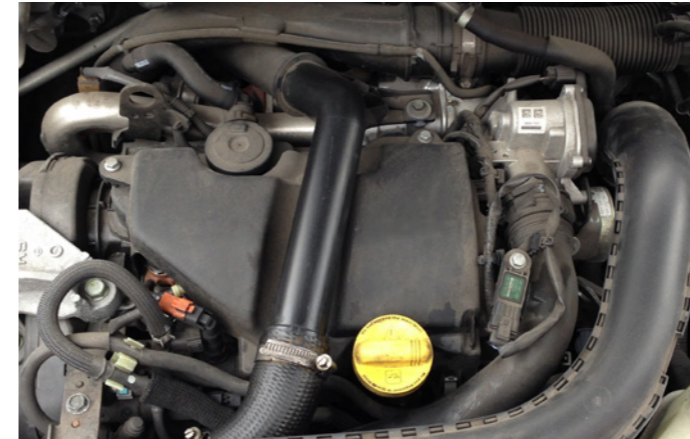
Example: Rocker Cover with vent valve.
