Blue Print ADC41473

Mitsubishi Airtrek 2.0i 2001>2006, Carisma 1.6i 1.8i 1995>2004, Colt 1.6i 1996>2004, FTO 1.8i 1995>2000, Galant 2.0i 1997>2004, Shogun Pinin 1.8i 2001>2006, Space Runner 2.0i 1999>2003, Space Star 1.3i 1.6i 1.8i 2000>2005, Space Wagon 2.0i 2.4i 1998>2004

IGNITION COIL FAILURE

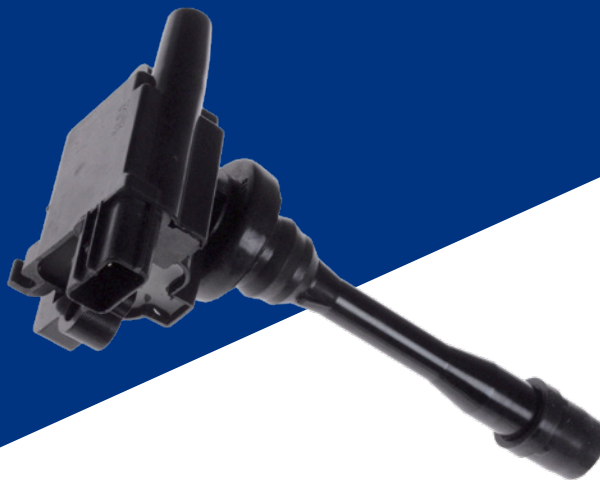
Progressive insulation failure of the coil or spark plug tube is most often experienced where a misfire is detected during cold/ damp conditions (e.g. from cold starts) or during high engine loads. This can be exacerbated by dirt contamination or high resistances in the spark plug or HT leads. Tracking can sometimes be visible or audible during operation, and may leave carbon traces where regular tracking to earth is occurring.

Example A was tracking from the coil body to the laminated core.

Blue Print strongly recommend that the spark plugs and HT leads are replaced in addition to the coil assembly, or that they are carefully checked. We also recommend that a logical diagnosis procedure is followed (prior to replacing the ignition coil) to prevent it being replaced unnecessarily.
