CV TROUBLE TRACER - BRAKE PADS AND DISCS

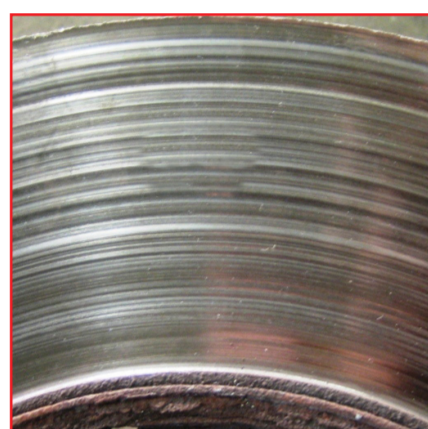
APPEARANCE Disc featuring scored surface.

CAUSE Pads fitted with friction material too harsh for the disc or new pads assembled on excessively worn out discs.

EFFECT Reduction in braking performance and possible imbalance on the affected axle during braking.

- Replace the pads.
- Check disc condition and minimum thickness.
- If necessary, replace the disc.
- Check for the quality of the spare parts used.

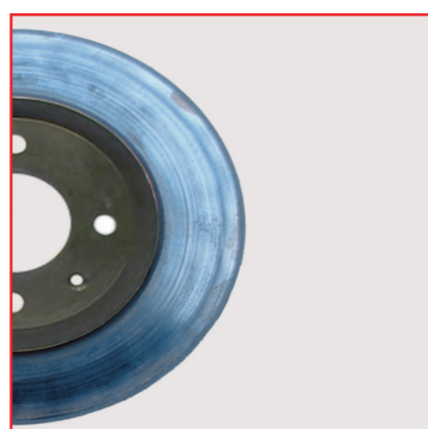
APPEARANCE Blue stripes on the disc indicating a physical change due to overheating.

CAUSE Intensive use of brakes for prolonged braking or improper downhill braking.

EFFECT Brake disc overheating which may result in contact surface distortion and cracks.

- Compulsory replacement of brake discs and pads.
- During the first 250 km after replacement, sharp braking should be avoided in order to allow for the correct bedding-in of the newly fitted components.

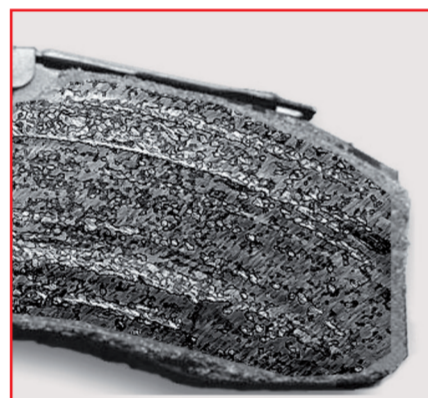
APPEARANCE Contaminated pad friction material.

CAUSE Contamination by an oily substance or solvent.

EFFECT Reduction in braking performance and possible imbalance during braking.

- Replace the pads.
- Check the discs on the axle.
- Identify any fluid leaks from the hubs or other nearby components.

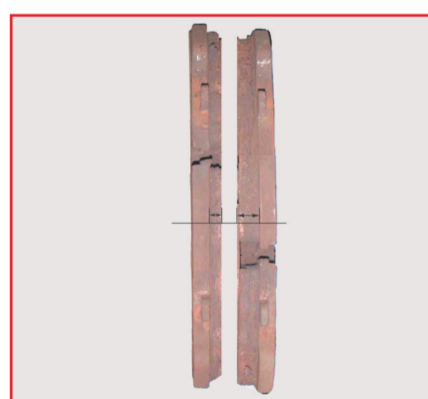
APPEARANCE Uneven brake pad wear.

CAUSE One of the calipers has become stuck or does not return correctly to the rest position.

EFFECT Reduction in braking performance and possible imbalance on the involved axle, during braking.

- Replace the pads.
- Brake calipers should be checked.

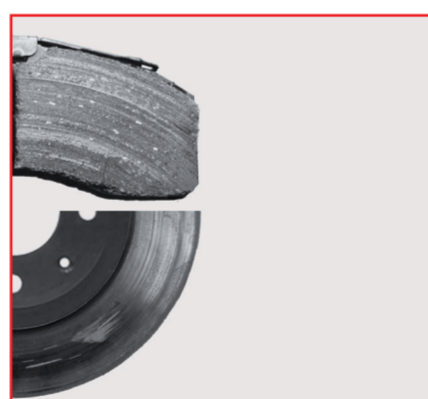
APPEARANCE Friction includes metal pick-up.

CAUSE High temperature generated between brake pad and disc in wet conditions.

EFFECT Wear of the affected brake disc with typical metal rubbing noise during braking.

- Replace the pads.
- Check disc condition and minimum thickness.
- If necessary, replace both discs on the axle.

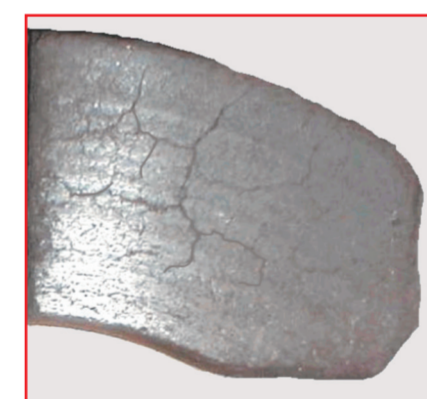
APPEARANCE Pad with surface cracks.

CAUSE Excessive load or high friction material temperature.

EFFECT Possible detachment of friction material resulting in a reduction in braking performance.

- Replace the pads.
- Check for correct caliper operation.
- Check disc condition and minimum thickness.
- If necessary, replace both discs on the axle.

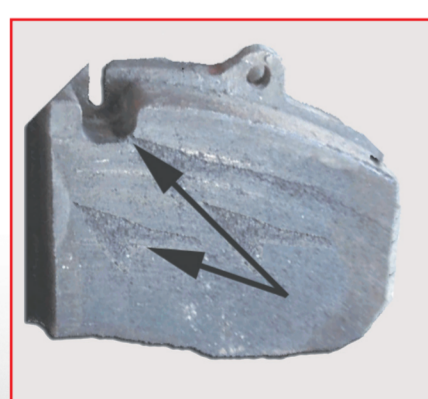
APPEARANCE Excessively worn out discs and pads

CAUSE Possible contamination of the friction material by sand, mud or earth or incomplete return of the caliper gear.

EFFECT Excessive wear of one or more brake pads, resulting in damage where the pad has not been fitted with a wear indicator.

- Replace the pads.
- Check disc condition and minimum thickness.
- If necessary, replace both discs on the axle.

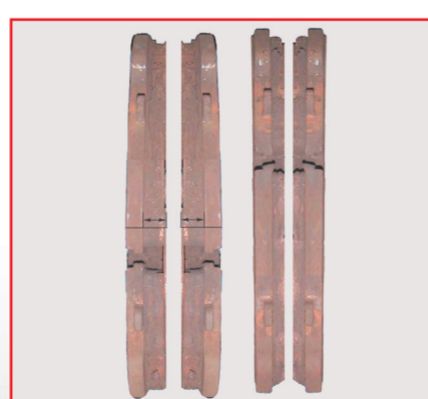
APPEARANCE Pads on the same axle featuring uneven wear.

CAUSE Incorrect return of one caliper on the same axle.

EFFECT If the axle involved is the directional one, this fault may result in vehicle instability during brake release.

- Replace the pads.
- Check for the proper caliper operation.
- Check disc condition and minimum thickness.
- If necessary, replace both discs on the axle.
