# Timing chain wear and the impact it has on engine performance

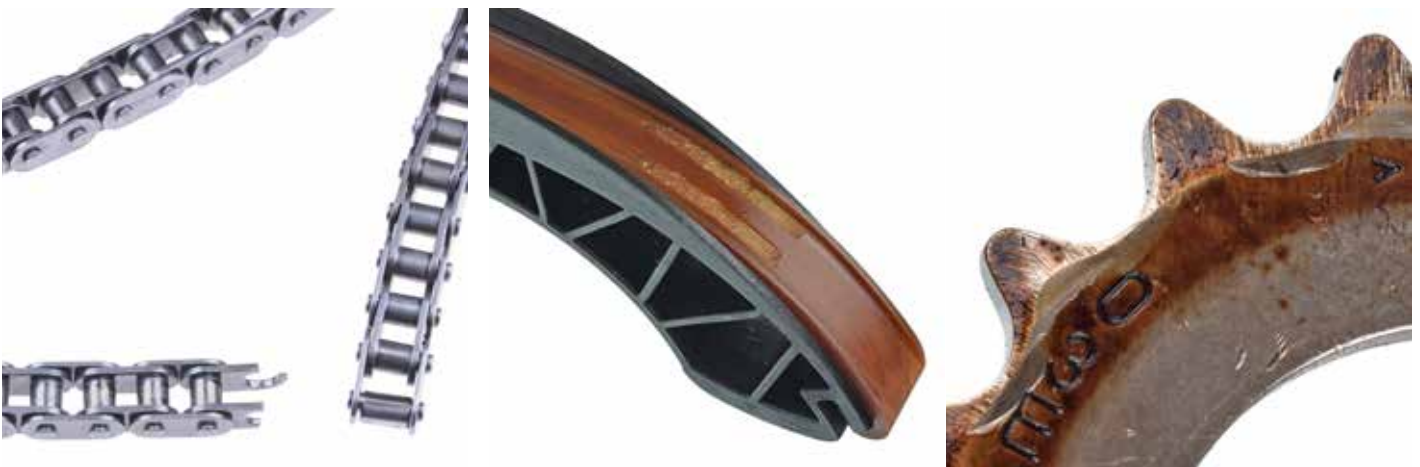
febi timing chain kits correspond to the latest technical developments, upgraded components are used, these include strengthened chain guides with optimised surface structure and superior quality chains treated with a TRITAN® coating. This coating improves friction properties to reduce wear and optimises engine fuel consumption. The sprockets in the kit are designed to reduce chain load and tensioners with improved damping characteristics. A complete febi chain repair kit has significant friction improving properties and strength for a confident replacement with improved noise, vibration and harshness qualities and efficiency features.
